Investigation and Retrofitting Proposal for a Panbo Type House in Sisimiut, Greenland

Qu, Jing; Vladyková, Petra; Villumsen, Arne

Publication date:
2012

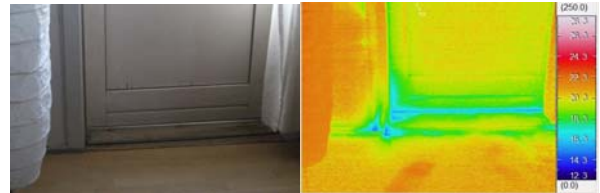
The thermography tests show that there are some problems with the building envelope, such as leaky windows, doors and building component joints. Some pictures are taken as examples to see the problems. (Figure 12, 13 and 14)

Figure 12: The leaking balcony door in the living room

According to the result of the investigation, the retrofitting work mainly consists of applying extra paper insulation layer and new climate shield, replacement of windows and doors, levelling up the living room floor and installation of mechanical ventilation system.

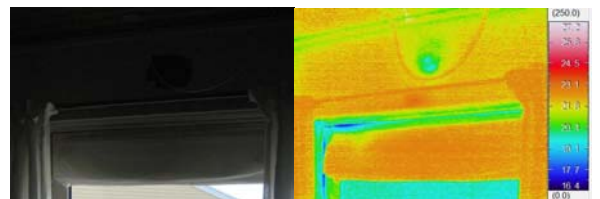
Figure 13: Untight window, natural vent and joints between the wall and the ceiling
